**Flood Control Project Maintenance
Levee Inspections**
LMA District Cover Sheet
Spring 2018 Levee Inspection Results

Sutter Maintenance Yard Maintenance Area 0001

Spring 2018 Levee Inspection Results

Waterway			Bank	Unit Miles
Unit No. 01 Sacramento River			Right	16.76
	Spring (March - May)	Summer (June - August)	(September - November) Fall	Winter (December - February)
Unit Maintenance Rating (Fall Only)				
Date of Inspection	3/6/2018 - 3/6/2018			
DWR Inspector	Bob Duffey			
Accompanied By	Bryan Reniff Sutter Maintenance Yard

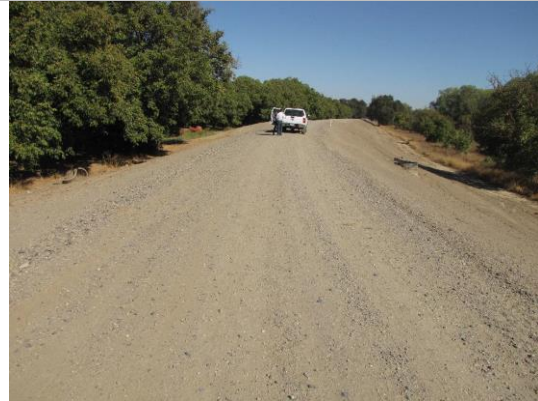
Photo 1 of 3 : UCIP_SP_2018_51852_70064.jpg

Comment Code						
Inspector Comment						
FS_ID:51852 DS_ID:16430 EP_NO: 9487 Repair Type: Non-Urgent Crossing Status: Found UCIP Comments: 5/3/2017 WS end still partially plugged. (DWR Sutter Yard- A Freitag)10/24/2016 Ws end is till partially plugged.(DWR Sutter Yard- A Freitag)4/25/2016 WS pipe end is still plugged with soil. Rest of the pipe appeared to be in good condition.4/20/2015 WS pipe end is plugged about 50% by soil.6/18/2014 Same as last inspection.12/17/2013 Same as last inspection.7/18/2013 WS pipe end has been reformed but is still clogged about 50% by sediment.10/18/2012 Remove dirt and debris in riser. Outlet deformed and blocked over 50%. Debris-round concrete section on landward side. This crossing was listed in the USACE Periodic Inspections as ID# USACE_CESPK_MA1C_2010_p_0116 for crossing outlet deformed and clogged with dirt. FIELD_STRUCT_DESC: 1 of 2: 36-inch corrugated metal drainage pipe through the levee, approximately 12-15 feet below the crown. Slide gates in corrugated metal pipe (CMP) riser located on the waterside (WS) slope. Pipe daylights on the landside (LS). (36-inch pipe [HLM 1.97] authorized under Automatic Board Order (ABO) issued as Permit No. 9487, 1974 - Jimeno Rancho) [Additional Reference(s): DWR Levee Log, 1992. USACE Sacramento O&M Manual 137, August 1955, (Station 103+18)]. FS Date: 5/19/2017 1:20:29 PM

Overview of levee crown and slopes looking upstream towards crossing.

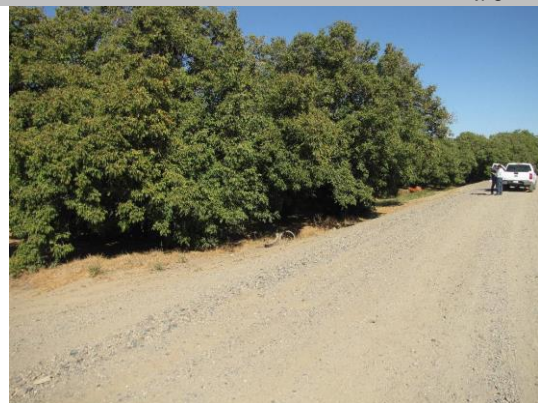
Photo 3 of 3 : UCIP_SP_2018_51852_70062.jpg

FS_ID:51852
DS_ID:16430
EP_NO: 9487
Repair Type: Non-Urgent
Crossing Status: Found
UCIP Comments: 5/3/2017 WS end still partially plugged. (DWR Sutter Yard- A Freitag) 10/24/2016 WS end is still partially plugged. (DWR Sutter Yard- A Freitag) 4/25/2016 WS pipe end is still plugged with soil. Rest of the pipe appeared to be in good condition. 4/20/2015 WS pipe end is plugged about 50% by soil. 6/18/2014 Same as last inspection. 12/17/2013 Same as last inspection. 7/18/2013 WS pipe end has been reformed but is still clogged about 50% by sediment. 10/18/2012 Remove dirt and debris in riser. Outlet deformed and blocked over 50%. Debris-round concrete section on landward side. This crossing was listed in the USACE Periodic Inspections as ID# USACE_CESPK_MA1C_2010_p_0116 for crossing outlet deformed and clogged with dirt.
FIELD_STRUCT_DESC: 1 of 2: 36-inch corrugated metal drainage pipe through the levee, approximately 12-15 feet below the crown. Slide gates in corrugated metal pipe (CMP) riser located on the waterside (WS) slope. Pipe daylights on the landside (LS). (36-inch pipe [HLM 1.97] authorized under Automatic Board Order (ABO) issued as Permit No. 9487, 1974 - Jimeno Rancho) [Additional Reference(s): DWR Levee Log, 1992. USACE Sacramento O&M Manual 137, August 1955, (Station 103+18)].

View of LS looking upstream at crossing.

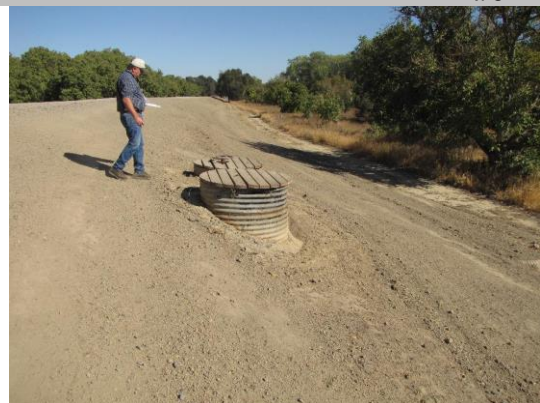
Photo 2 of 3 : UCIP_SP_2018_51853_70074.jpg

FS_ID:51853
DS_ID:17565
EP_NO: 9487
Repair Type: Non-Urgent
Crossing Status: Found
UCIP Comments: 5/3/2017 Ws end still partially plugged. (DWR Sutter Yard- A Freitag) 10/24/2016 Ws pipe end still plugged. (DWR Sutter Yard- A Freitag) 4/25/2016 WS pipe end still plugged with soil. rest of pipe appears in good condition. 4/20/2015 WS pipe end plugged about 50% by soil. 6/18/2014 Same as last inspection. 12/17/2013 Same as last inspection. 7/18/2013 WS pipe end has been reformed but is still partially blocked with dirt and debris. 10/18/2012 WS-remove dirt and debris in riser. Outlet deformed and blocked over 50%. Burrow activity near outlet on waterward slope. Debris around concrete section on landward side. This crossing was listed in the USACE Periodic Inspections as ID# USACE_CESPK_MA1C_2010_p_0116 for crossing outlet deformed and clogged with dirt.
FIELD_STRUCT_DESC: 2 of 2: 36-inch corrugated metal drainage pipe through the levee, approximately 12-15 feet below the crown. Slide gates in corrugated metal pipe (CMP) riser on the waterside (WS) slope. Pipe daylights on the landside (LS). (36-inch pipe [HLM 1.97] authorized under Automatic Board Order (ABO) issued as Permit No. 9487, 1974 - Jimeno Rancho) [Additional Reference(s): DWR Levee Log, 1992. USACE Sacramento O&M Manual 137, August 1955, (Station 103+18)].

View of CMP risers located on WS slope.

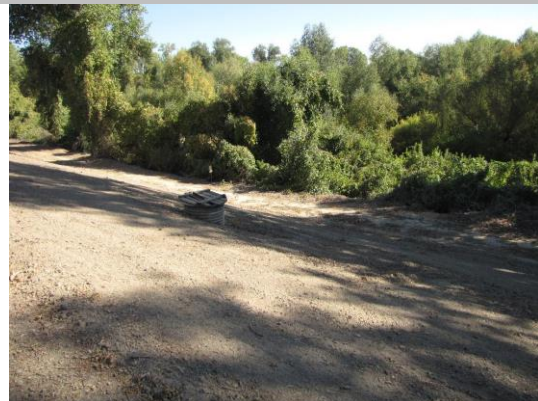
Photo 2 of 3 : UCIP_SP_2018_51855_70084.jpg

Comment Code						
Inspector Comment						
FS_ID:51855 DS_ID:16428 EP_NO: 9467 Repair Type: Non-Urgent Crossing Status: Found UCIP Comments: 5/3/2017 Abandoned- needs to be done so properly. (DWR Sutter Yard- A Freitag)10/24/2016 Abandoned.(DWR Sutter Yard- A Freitag)4/25/2016 Abandoned crossing. Unable to locate any WS and LS pipe ends.4/20/2015 Same as last inspection.6/18/2014 Same as last inspection.12/17/2013 Same as last inspection.7/18/2013 Same as last inspection.10/18/2012 Only riser visible. Debris and sediment blocking gate. Gate inside riser is buried and non-functional. If crossing is abandoned, owner needs to properly abandon. This crossing was listed in the USACE Periodic Inspections as ID# USACE_CESPK_MA1C_2010_p_0132 no culvert through the levee is visible here. FIELD_STRUCT_DESC: *ABANDONED* 24-inch corrugated metal drainage pipe through the levee, approximately 12-15 feet below the crown. Slide gate in CM pipe riser on the waterside (WS) slope. No signs of inlet visible on the landside (LS). (24-inch pipe [HLM 2.31] authorized under Automatic Board Order (ABO) issued as Permit No. 9467, 1974 - Lovell E. Spurgeon) [Additional Reference(s): DWR Levee Log, 1992. USACE Sacramento O&M Manual 137, August 1955, (Station 120+60)]. FS Date: 5/19/2017 1:48:04 PM

View of WS slope and toe.

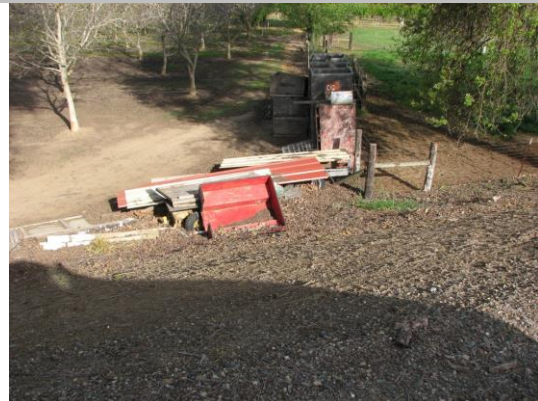
Photo 1 of 1 : SP_2018_MA0001_297_80_20180305_00017.jpg

LM Start	2.25	Rating **	M	Issue No.	80
LM End	2.25	Issue Type +	En	Location *	LS
Category	Earthen Levee			GPS Latitude/Longitude	
				Start	End
Item	Encroachments			39.236211 °	39.236211 °
				-122.012775 °	-122.012775 °
DWR ID	DWR_MA0001_01_s_2016_80				
Comment Code					
DE : Debris					
Inspector Comment					
Remove the metal roofing and other debris.

View of the equipment and debris obstructing access.

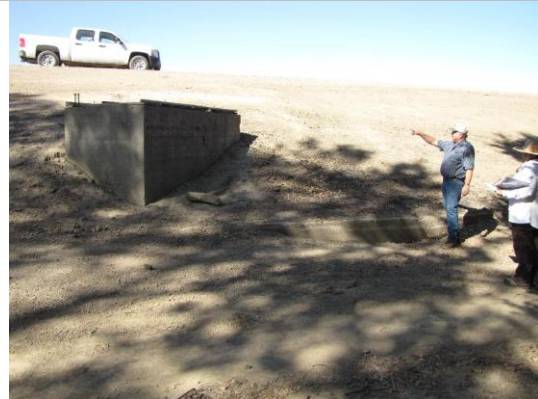
Photo 2 of 3 : UCIP_SP_2018_51857_70107.jpg

Comment Code					
Inspector Comment					
FS_ID:51857 DS_ID:17567 EP_NO: 9474 Repair Type: Non-Urgent Crossing Status: Found UCIP Comments: 5/3/2017 Appears abandoned- WS vault full of soil. Needs to be abandoned properly. (DWR Sutter Yard- A/Freitag)10/24/2016 Appears to be abandoned. WS vault full of soil to help prevent water from flowing through during high water season.(DWR Sutter Yard- A/Freitag)4/25/2016 Concrete box on WS was filled with soil to help prevent water form flowing through during times of high water.4/20/2015 Positive closure device is missing and water cannot be prevented from flowing through pipe during high water.6/18/2014 Same as last inspection.12/17/2013 Same as last inspection.7/18/2013 Same as last inspection.10/18/2015 During high water flow goes through levee. Missing positive closure device on waterward side. This structure appears abandoned-slide gates have been removed. Crossing needs to be properly abandoned. This crossing was listed in the USACE Periodic Inspection as ID# USACE_CESPK_MA1C_2010_p_0169 for concrete box partially filled with dirt. FIELD_STRUCT_DESC: 2 of 2: 60-inch reinforced concrete irrigation pipe through the levee, approximately 12-15 feet below the crown. Crossing goes through the levee at an angle. Slide gates in concrete well at the waterside (WS) toe. Slide gate missing. (Automatic Board Order (ABO) issued as Permit No. 9474, 1974 - George R. Zumwalt) O&M manual description is for two 5-foot by 5-foot concrete culverts with two hand operated slide gates. Culvert constructed with wing walls and gate well. [Additional Reference(s): DWR Levee Log, 1992. USACE Sacramento O&M Manual 137, August 1955, (Station 150+06)]. FS Date: 5/19/2017 1:49:51 PM

Concrete distribution box and headwall located on WS.

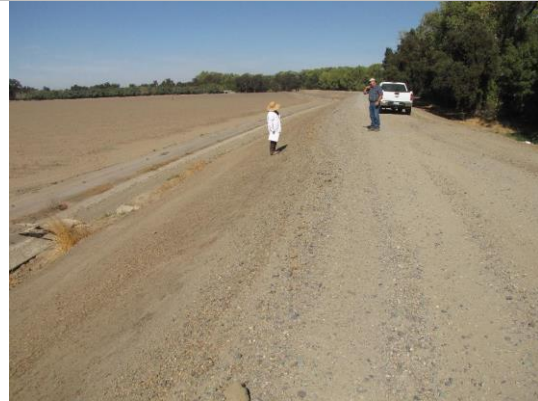
Photo 1 of 3 : UCIP_SP_2018_51859_70110.jpg

Comment Code						
Inspector Comment						
FS_ID:51859 DS_ID:16426 EP_NO: 9490 Repair Type: Non-Urgent Crossing Status: Found UCIP Comments: 5/3/2017 Sediment build up in WS pipe end. WS slide gate stem bent but it does not affect its operation. (DWR Sutter Yard- A Freitag)10/24/2016 WS slide gate stem is still bent.(DWR Sutter Yard- A Freitag)4/25/2016 WS slide gate is slightly bent. Rest of crossing appears to be in good condition. 4/20/2015 LS inlet still has some minor sediment build up. Needs to be cleaned.6/18/2014 Same as last inspection.12/17/2013 Same as last inspection.7/18/2013 WS slide gate looks to be in good condition but stem is slightly bent. Not sure if bend will hinder gates operation or not. LS inlet is still blocked by minor sediment build up.10/18/2012 LS pipe slightly deformed and sediment build up blocking about 30% of opening; need to check the condition of the slide gate-need photo. Metal marker down. This crossing was listed in the USACE Periodic Inspection as ID# USACE_CESPK_MA1C_2010_p_0187 for sediment build up at landward toe. FIELD_STRUCT_DESC: 36-inch corrugated metal drainage pipe through the levee, approximately 12-15 feet below the crown. Slide gate in corrugated metal pipe (CMP) riser on the waterside (WS) slope. (36-inch pipe [HLM 3.78] authorized under Automatic Board Order (ABO) issued as Permit No. 9490, 1955 - Charles & Virginia Yerxa) [Additional Reference(s): DWR Levee Log, 1992. USACE Sacramento O&M Manual 137, August 1955, (Station 177+67)]. FS Date: 5/19/2017 1:53:31 PM

View of LS looking upstream.

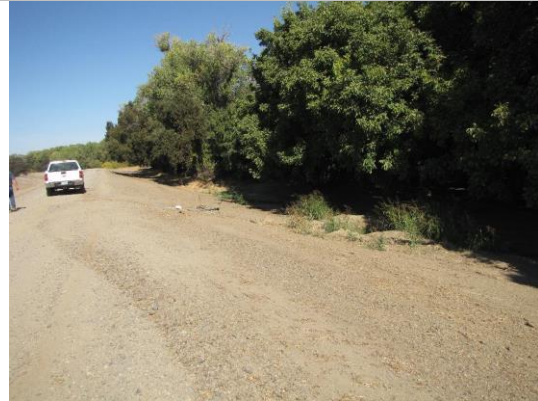
Photo 2 of 3 : UCIP_SP_2018_51859_70109.jpg

Comment Code						
Inspector Comment						
FS_ID:51859 DS_ID:16426 EP_NO: 9490 Repair Type: Non-Urgent Crossing Status: Found UCIP Comments: 5/3/2017 Sediment build up in WS pipe end. WS slide gate stem bent but it does not affect its operation. (DWR Sutter Yard- A Freitag)10/24/2016 WS slide gate stem is still bent.(DWR Sutter Yard- A Freitag)4/25/2016 WS slide gate is slightly bent. Rest of crossing appears to be in good condition. 4/20/2015 LS inlet still has some minor sediment build up. Needs to be cleaned.6/18/2014 Same as last inspection.12/17/2013 Same as last inspection.7/18/2013 WS slide gate looks to be in good condition but stem is slightly bent. Not sure if bend will hinder gates operation or not. LS inlet is still blocked by minor sediment build up.10/18/2012 LS pipe slightly deformed and sediment build up blocking about 30% of opening; need to check the condition of the slide gate-need photo. Metal marker down. This crossing was listed in the USACE Periodic Inspection as ID# USACE_CESPK_MA1C_2010_p_0187 for sediment build up at landward toe. FIELD_STRUCT_DESC: 36-inch corrugated metal drainage pipe through the levee, approximately 12-15 feet below the crown. Slide gate in corrugated metal pipe (CMP) riser on the waterside (WS) slope. (36-inch pipe [HLM 3.78] authorized under Automatic Board Order (ABO) issued as Permit No. 9490, 1955 - Charles & Virginia Yerxa) [Additional Reference(s): DWR Levee Log, 1992. USACE Sacramento O&M Manual 137, August 1955, (Station 177+67)]. FS Date: 5/19/2017 1:53:31 PM

View of WS looking upstream.

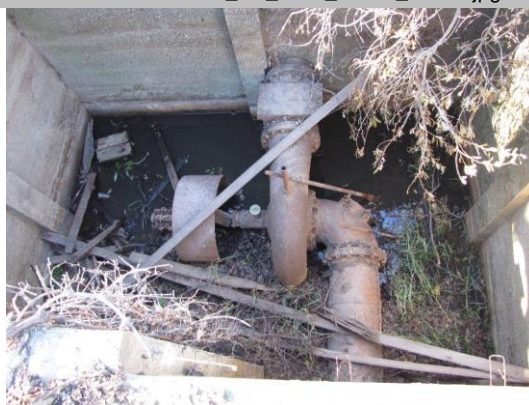
Photo 2 of 3 : UCIP_SP_2018_51861_70123.jpg

Abandoned pump system inside concrete structure located on LS.

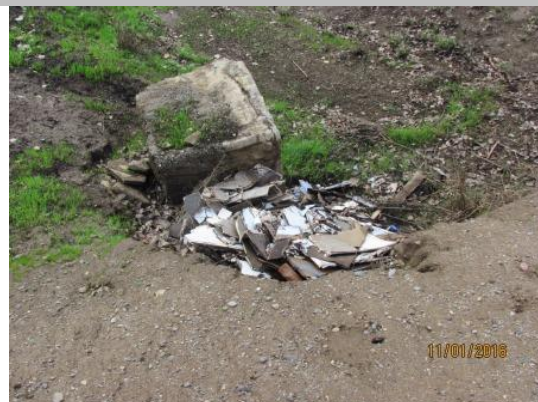
Photo 1 of 2 : SP_2018_MA0001_297_114_20180305_00033.jpg

View of the dry wall debris used for erosion control along the downstream side of the ramp.

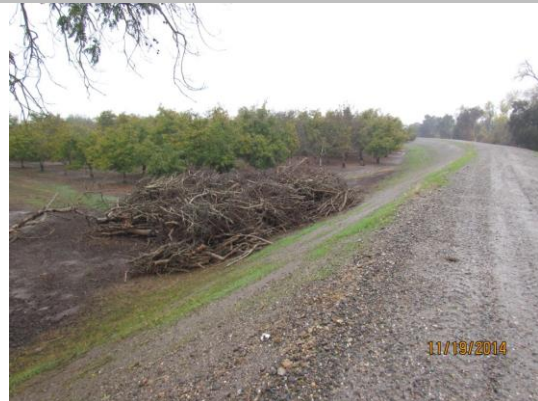
Photo 1 of 1 : SP_2018_MA0001_297_636_20180305_00042.jpg

View of the pruning along the landside toe.

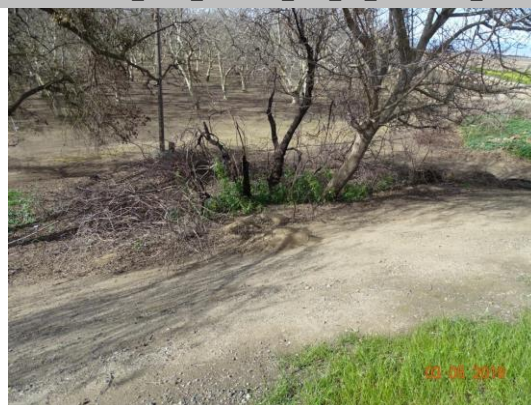
Photo 1 of 1 : SP_2018_MA0001_297_69_20180312_00151.jpg

View of the rodent holes along the landside slope.

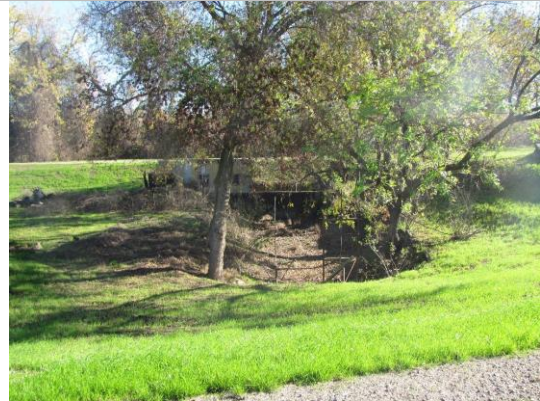
Photo 2 of 3 : UCIP_SP_2018_51889_70265.jpg

View of abandoned structure located on WS (inside ring levee).

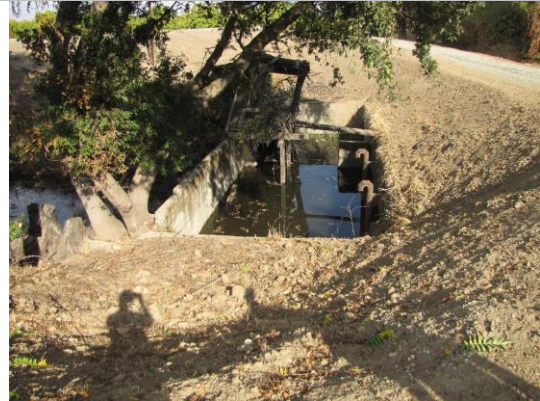
Photo 2 of 3 : UCIP_SP_2018_51891_70276.jpg

Abandoned structure (multiple headwalls and pump structure) located near the lower levee (ring levee).
